QUARTERLY SITE INSPECTION REPORT

FEBRUARY 1998

**BAILEY SUPERFUND SITE
ORANGE COUNTY, TEXAS**

PARSONS ENGINEERING SCIENCE, INC.

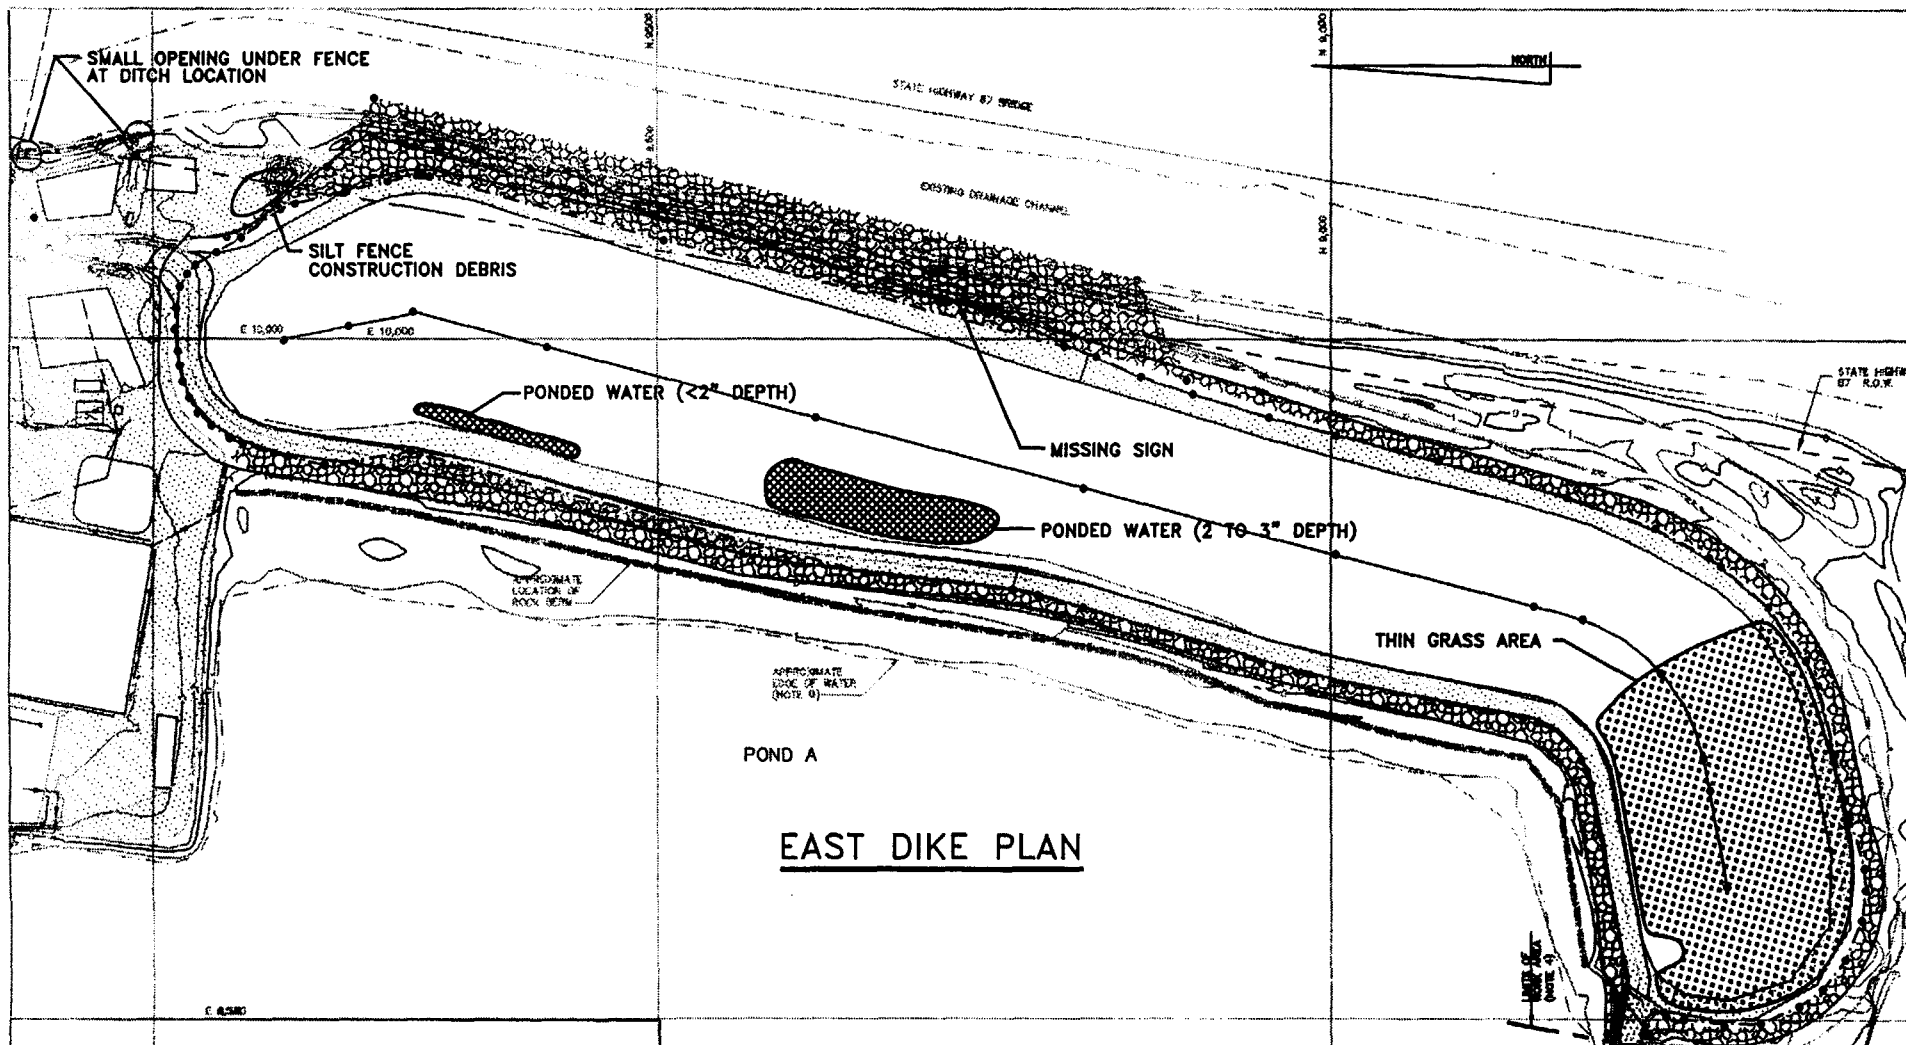
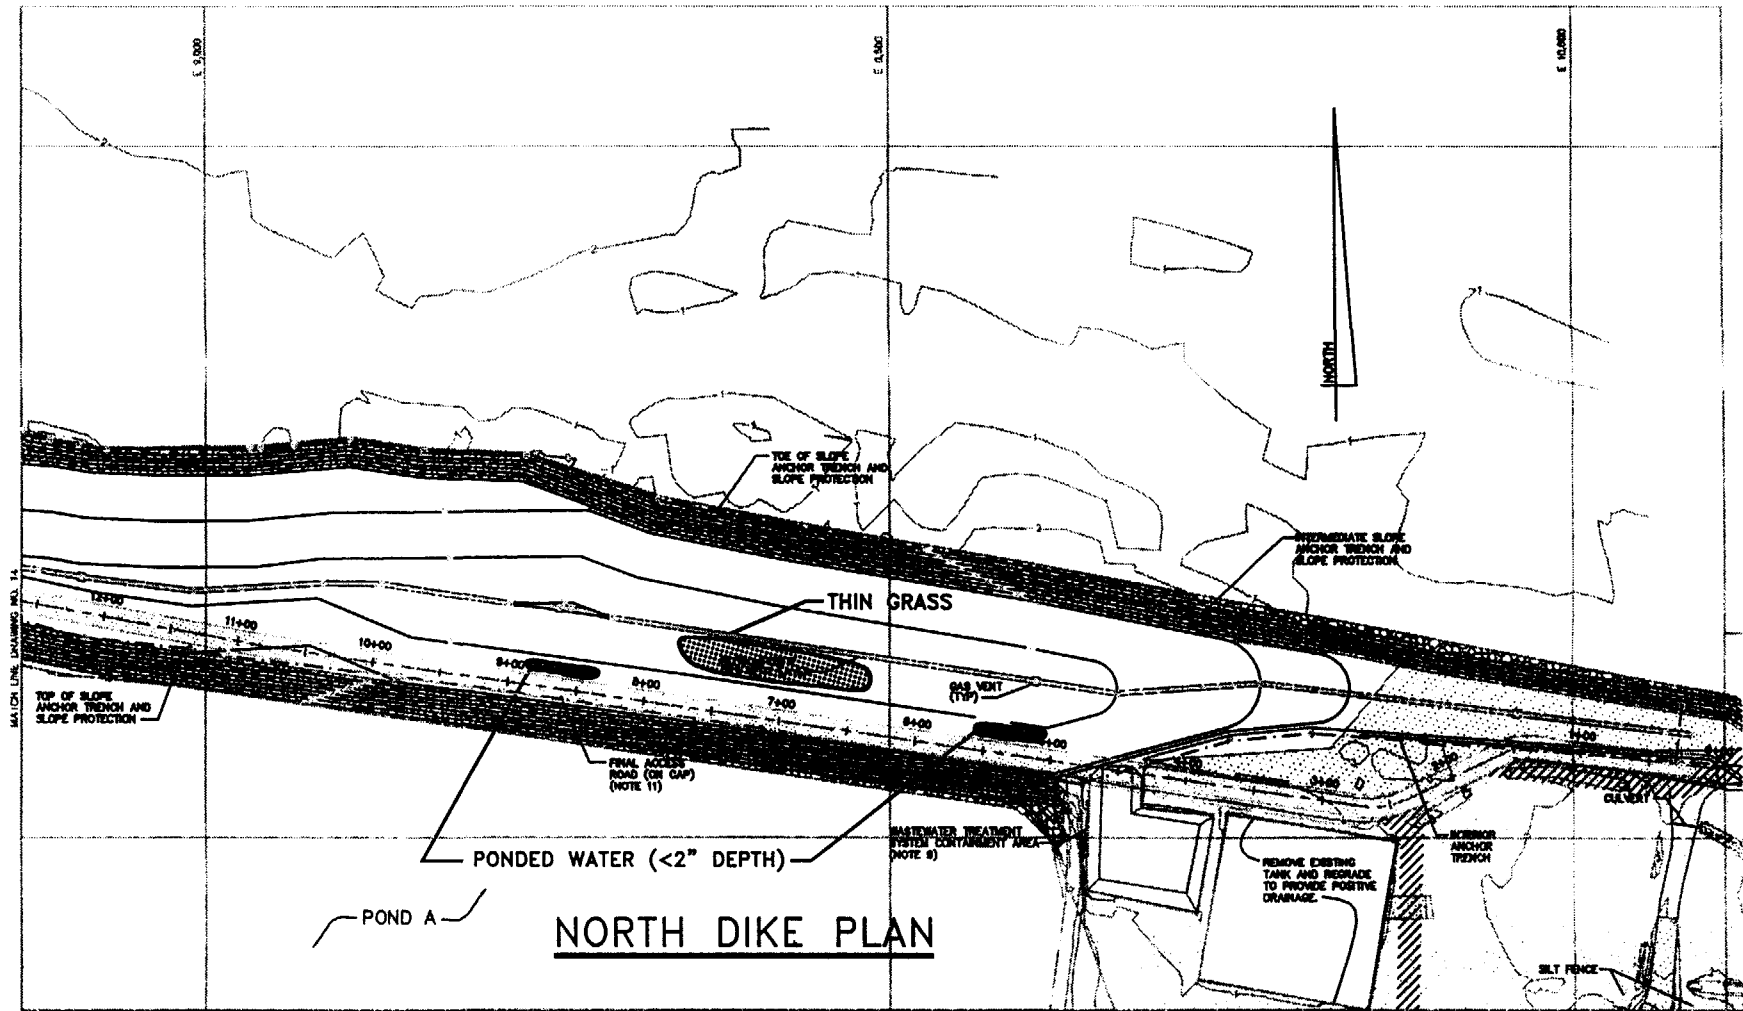
SITE MAPS

The North and East Dike areas were carefully observed for signs of differential settlement. Some ponding generally less than 2 inches in depth was noted along the edge of the access road of the East and North Dikes. One area located on the East Dike was noted to be approximately 2 to 3 inches in depth. The ponding is believed to be attributed to the saturated soil conditions from the abnormal to date precipitation and the recent heavy rainfall that occurred prior to the inspection. The ponding was very similar to the ponding that was observed during the last quarterly inspection. No evidence, such as distressed vegetation, indicated that this area was not draining properly. The ponding locations are noted on the map provided in Appendix B. One visual observation of possible differential settlement was noted on the North Dike area. This location was on the rip-rap at the western end of the North Dike on the Pond A bank, which is outside of the lightweight geosynthetic composite cap limits. A section of approximately 20 LF in

length appears to have a dip of approximately 1 foot or less in the middle of the slope from adjacent areas. This location was noted on the map provided in Appendix B. This is the same location that was observed during the last Quarterly Inspection conducted on November 21, 1997. Little change appears to have taken place since the last inspection. No cracking was observed in the immediate area or any other signs of distress to the nearby cap areas.

The length of the fence was walked and observed to be in good condition. The gates and locks were inspected and found to be in good working order. The signs around the perimeter of the site were properly posted and visible. One sign was found to be missing along the fence of the East Dike drainage channel. The location of the missing sign is noted on the map provided in Appendix B.
